**Benton District Historic Resources  
Survey and Inventory**

*Prepared by*  
**Diana J. Painter, PhD**  
**Sonoma State University**

*for*  
**Anth. 592 – Special Topics in CRM**

**Fall 2004**

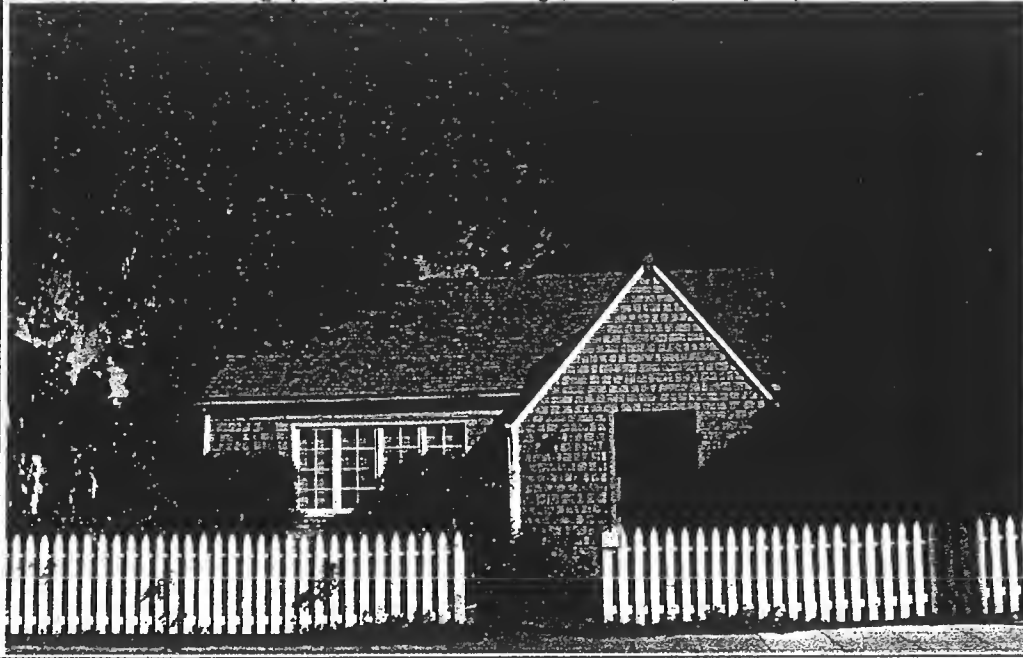
This is one-story, 1926 cottage has a rectangular footprint and asymmetrical façade with a cross-gable roof. The side gable has a moderate slope. The front-facing gable, which contains the front entry, reveals the building's Tudor Revival influences with its asymmetrical and steeply-pitched roof. There is a shed-roof extension to the rear of the structure. The roof is composition shingle. The house is clad in wood shingles, which replaced the original board and batten still visible on shed end. The single, front door is recessed within the gable front, and situated at the east end of the front façade. It has one step leading to it. The tall, narrow eight-light casement windows are presented in groups of four, separated by wide mullions, on the front and east facades. An exterior brick chimney is located on the west facade. The front door is plain with one seven-inch square light. Door and windows have plain trim. The gable has simple pendant; and no eaves. The main side-gable roof edge has gutters close to the wall. This is a one bedroom, one bath home with much of the original interior integrity visible. The main hall of the original campfire girl's home is at the main entrance, with the kitchen, bed, and bath behind. A high ceiling with exposed rafters is visible in this living space, as well as the original board and batten walls in the small kitchen. A small shed is located in the northeast corner of the backyard next to a large redwood.

P5b. Description of Photo: (View, date, accession #)  
View looking north taken 14 September 2004

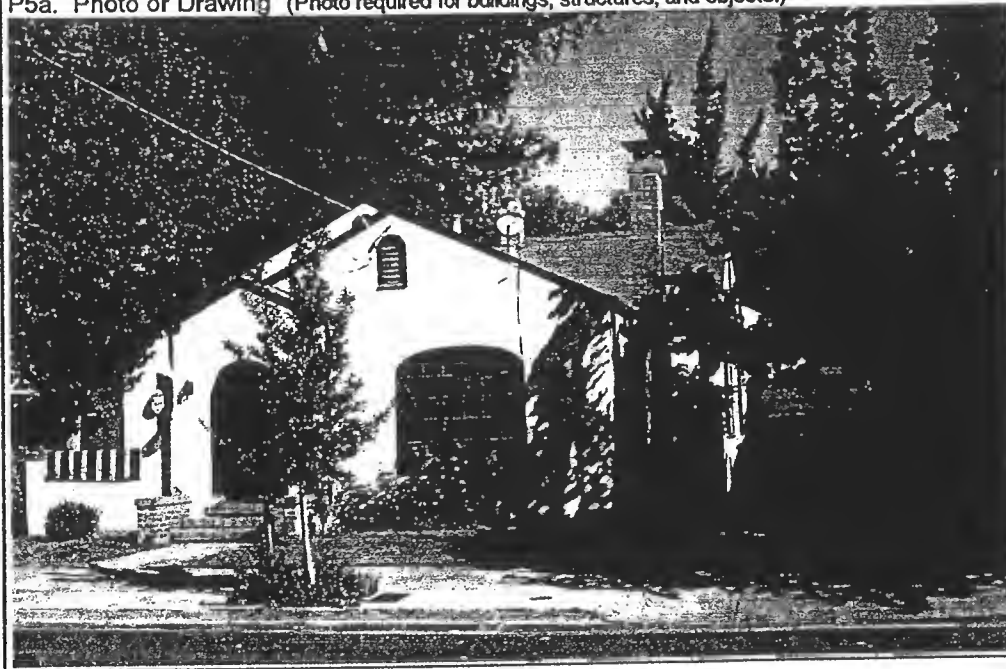
**\*P3a. Description:** (Describe resource and its major elements. Include design, materials, condition, alterations, size, setting, and boundaries)  
This is a one-story, wood frame building with a stucco finish. It has an irregular footprint and a moderately pitched cross-gable roof of composition shingle. There is an attached garage at the rear northeast corner of the building.

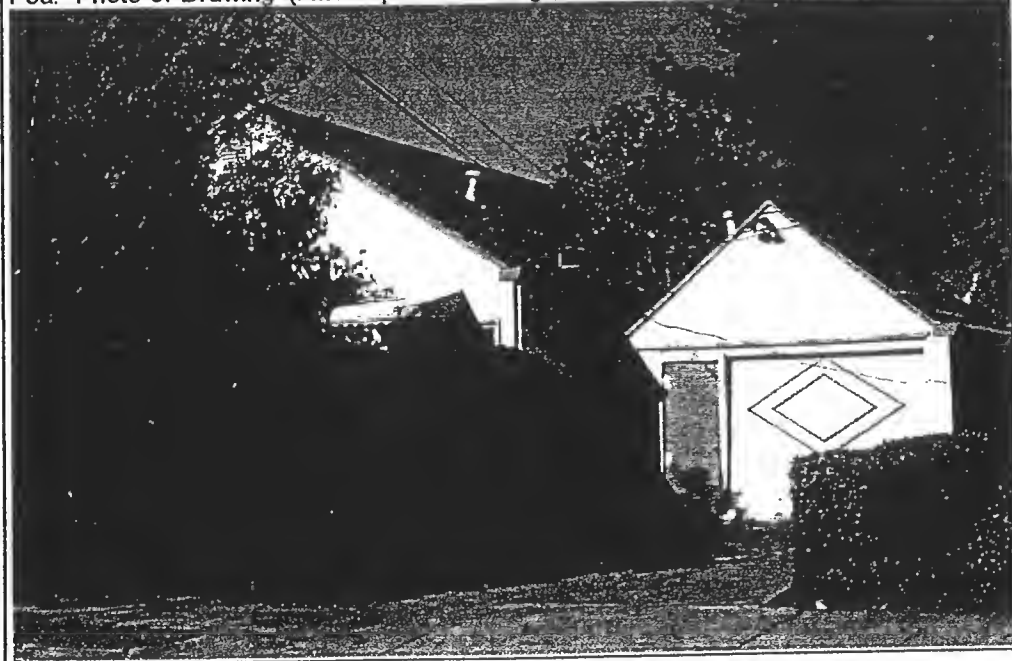
**P5b. Description of Photo:** (View, date, accession #)  
View toward the west taken 20 September 2004

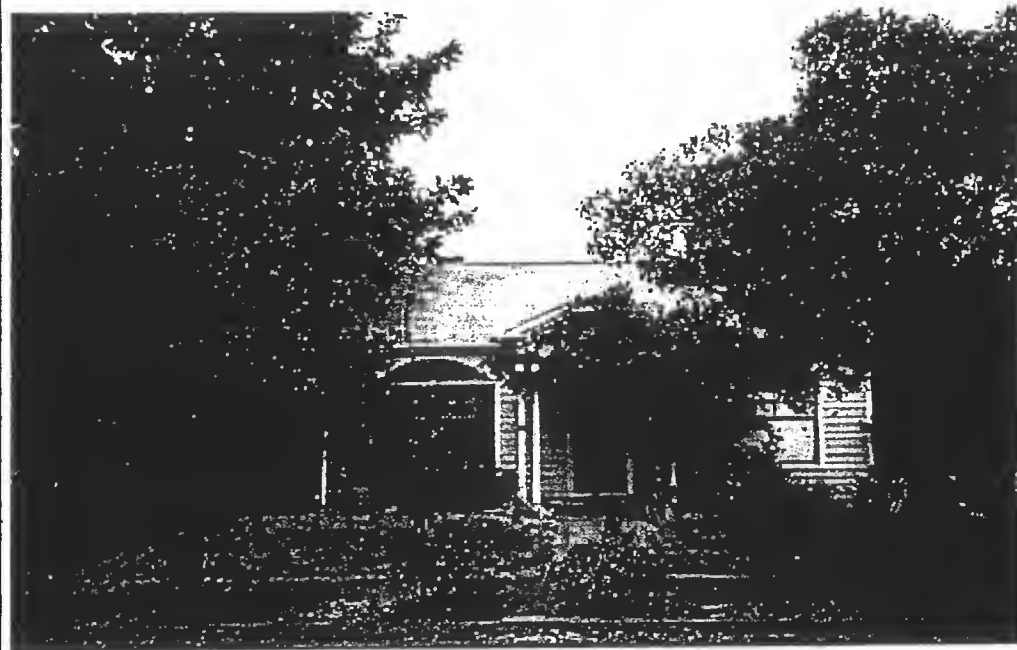
P5b. Description of Photo: (View, date, accession #) North elevation viewed from Howard St.; October 4, 2004; Accession # 8337140-R1-032-14A jpg

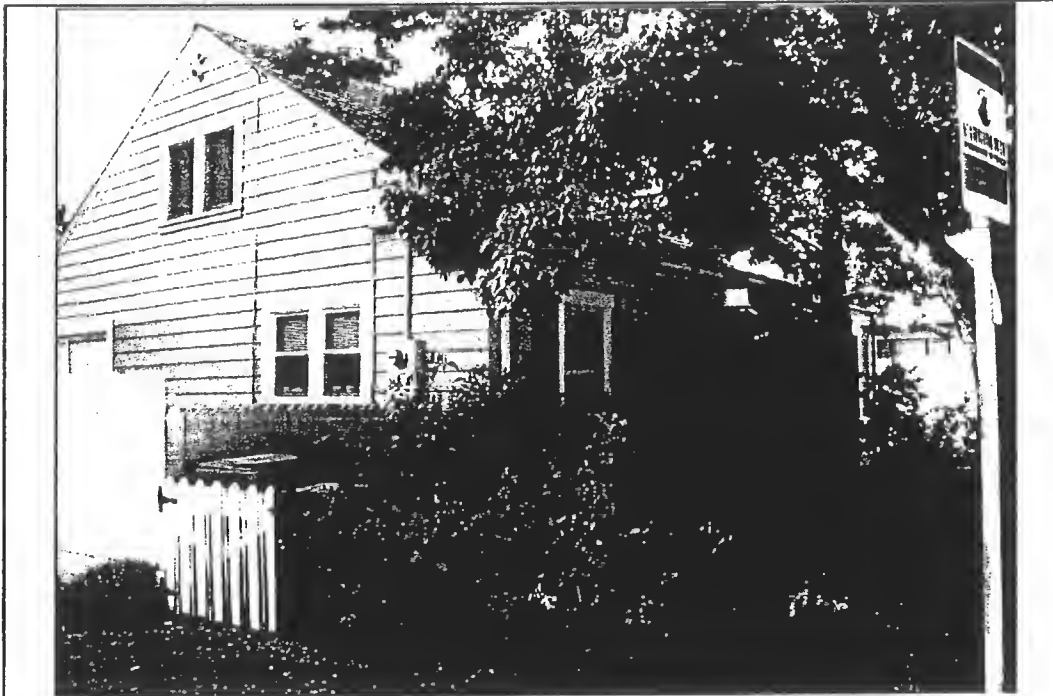
This 1937 one-and-one-half story house is located on the west side of the intersection of Howard street and the alley that runs north-south through the block bordered by Benton, Beaver, King, and Howard streets. It faces north onto Howard street. It is a wood frame construction with a perimeter concrete foundation and a rectangular footprint. The side gable-roof has moderate pitch, no eaves and composition shingles.

The exterior finish is horizontal clapboard siding. The front façade contains a wood door with a multi-light window with diamond-shaped panes. It is covered by a small visor roof supported by brackets. To the west of this door is a stone-faced chimney. On the east side of this door and the west side of the chimney are double-hung aluminum sash windows with louvered shutters. On the west side of the house is a double-hung aluminum sash window with a small roof extending over it. To the south of this are three two-over-two double-hung windows with aluminum sash and wood surrounds. These are irregularly placed suggesting that they were later additions. At the top of this wall is another double-hung aluminum-sash window. Windows on the east side of the house are also double-hung with aluminum sash and wide wood surrounds. (see Continuation Sheet)

View of front and east façade,  
photo facing southwest.

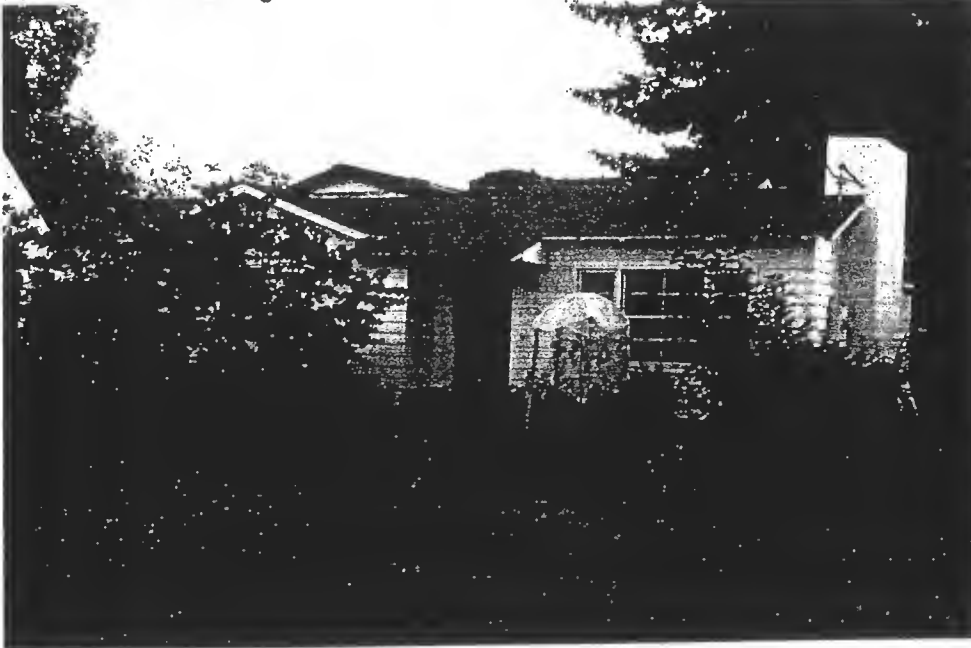
This 1937 house has an L-shaped footprint and is approximately 40 feet in width and 20 feet deep (personal communication, Mr. Gaevert, owner). The alley between Benton and Howard streets runs along the western side of the lot. The side gable roof house is composition shingle and features a gable front on the east side of the front façade. A 20-by-25 foot detached wood garage with horizontal siding, which is in deteriorating condition, sits at the rear of the lot.

North-facing elevation, viewed from  
Howard St. 3 Oct 2004

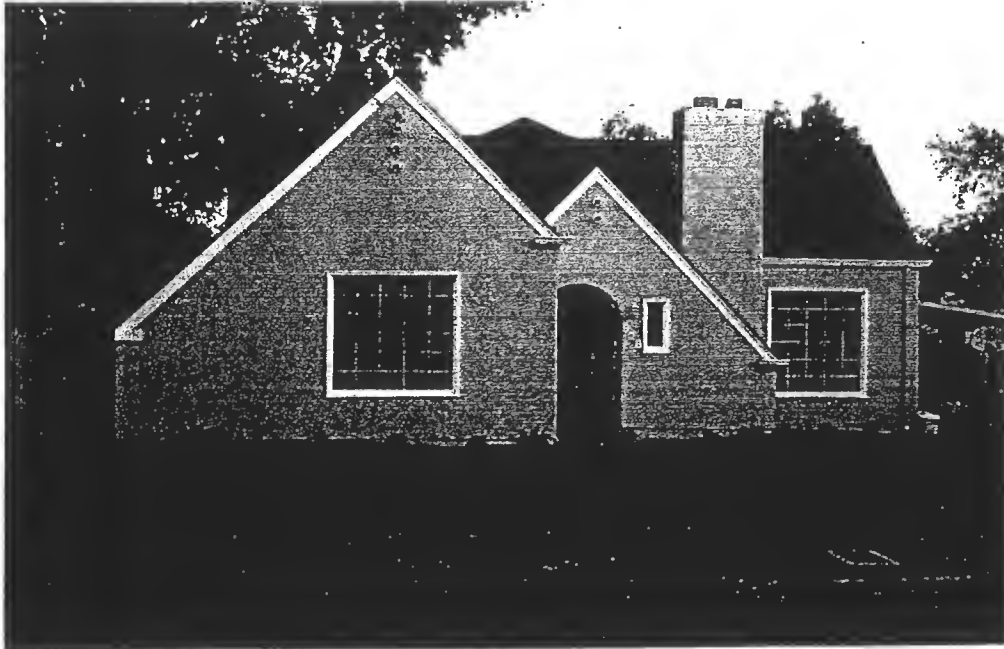
This one-story house is wood-frame construction on an at-grade concrete foundation and composition shingle roof. It has an irregular T-shaped floor plan. The cross-gable roof features two steeply pitched, front-facing, asymmetrical gables with gable returns and no eaves. The rear of the house features a 1 1/2-story addition.

P5b. Description of Photo:  
North-facing elevation, viewed  
from Howard St. 3 Oct 2004

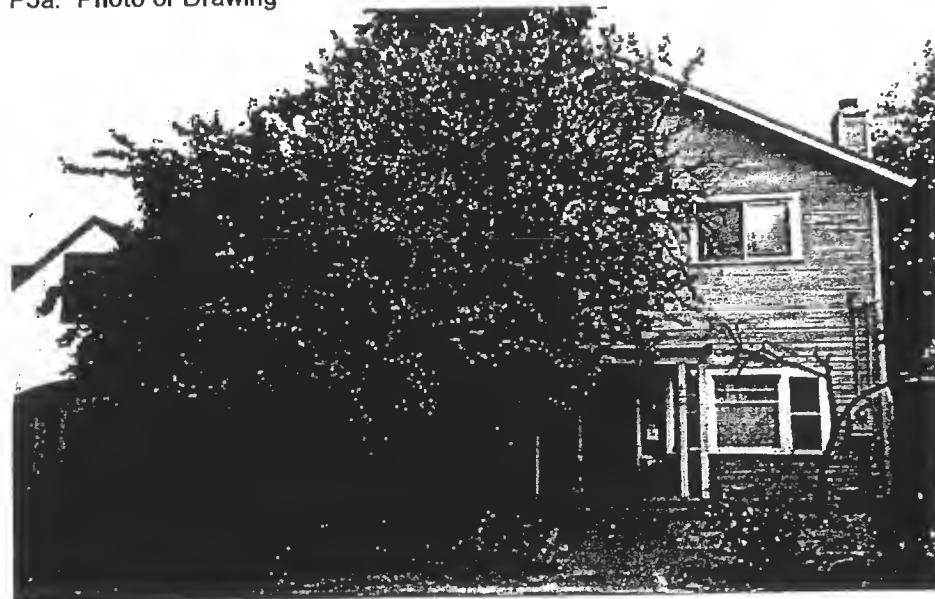
P5b. **Description of Photo:**  
North elevation view from  
Howard St.; October 4, 2004;  
Accession # 8337748-R1-044-  
20A.jpg

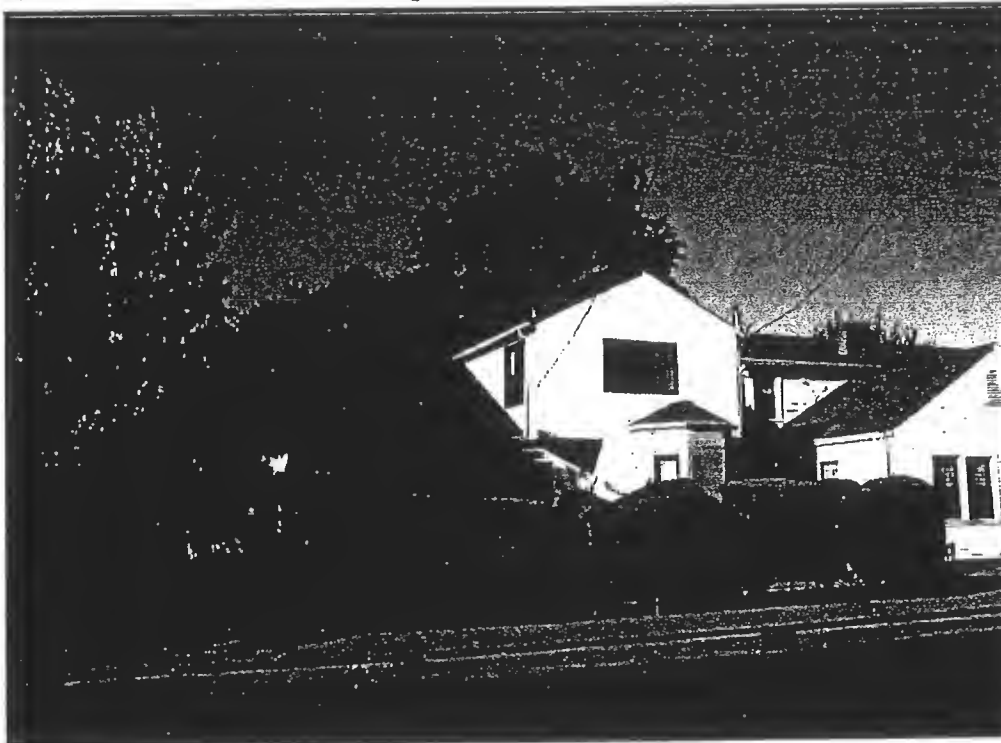
P5b. Description of Photo:  
View of 800 Humboldt, facing  
north-northeast.

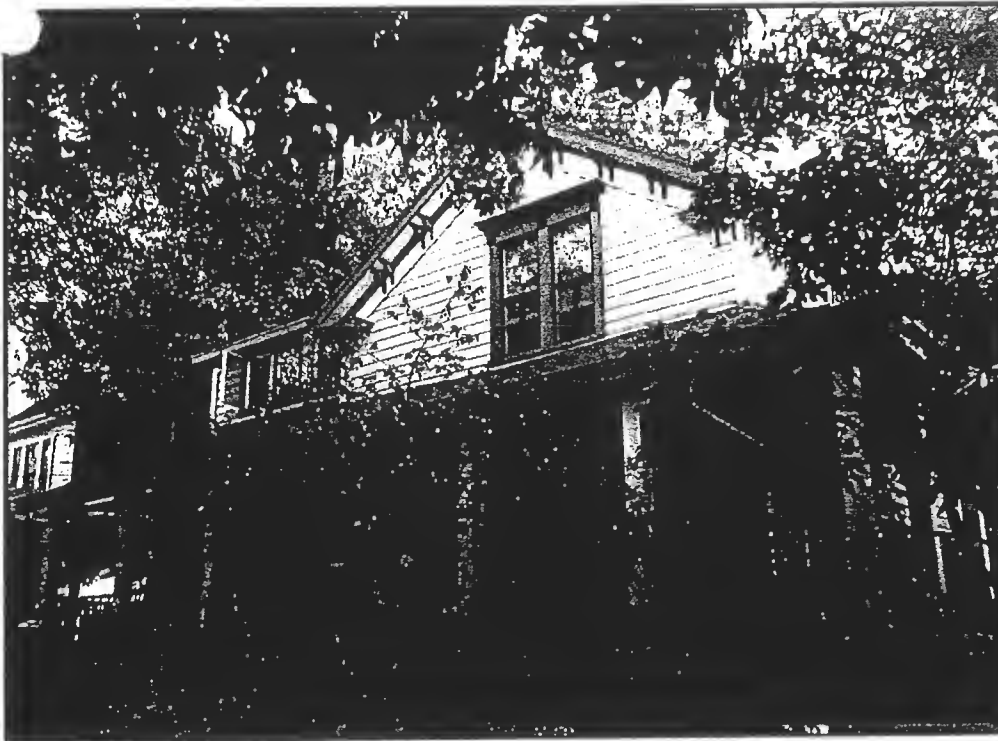
View of 808 Humboldt, facing northeast.

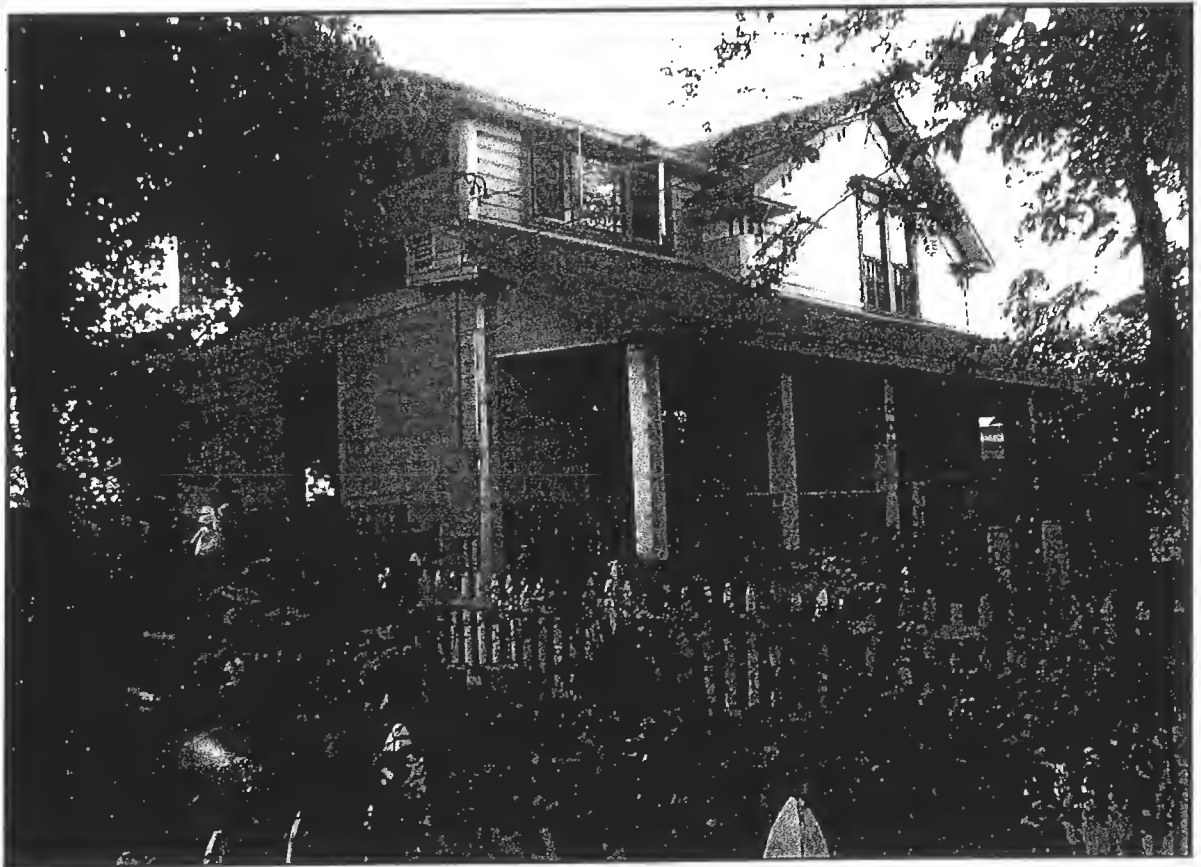
The west façade fronts on Humboldt Street, where the entrance to the porch leads to the main door of the house. The wrap-around porch, with a decorative wood balustrade, is supported by square posts with painted wood brackets. Above the door is a stained glass transom light. The four-paneled door, with the top two panels arched, is flanked by two pairs of windows, which are arranged asymmetrically. The windows are comprised of two-over-two-light double-hung sash with a simple flat wood surround. Above the porch at the gable, is a window consisting of a paired set of two-over-one- fixed windows, with a flat wood surround, and decorative hood molding with three consoles. This gable is decorated with pairs of brackets accenting the overhang, and has slight eave returns with the paired brackets. To the north of the gable, there is a tripartite window consisting of a central fixed light with two vertically-oriented casement windows to each side. The north façade of the building has two one-over-one-light double-hung sash windows on the first floor. On the second floor is a cluster of three small horizontally-oriented fixed-light windows and a separate single-light fixed casement window to the east. The east façade of the building faces the back alley, but was not visible due to a high fence along the alley property boundary. The south façade, under the porch, has a pair of windows identical to the west façade. Just to the east of those windows is a two-over-two-light vertically-oriented sliding sash window.

View of 808 Humboldt, looking southeast.

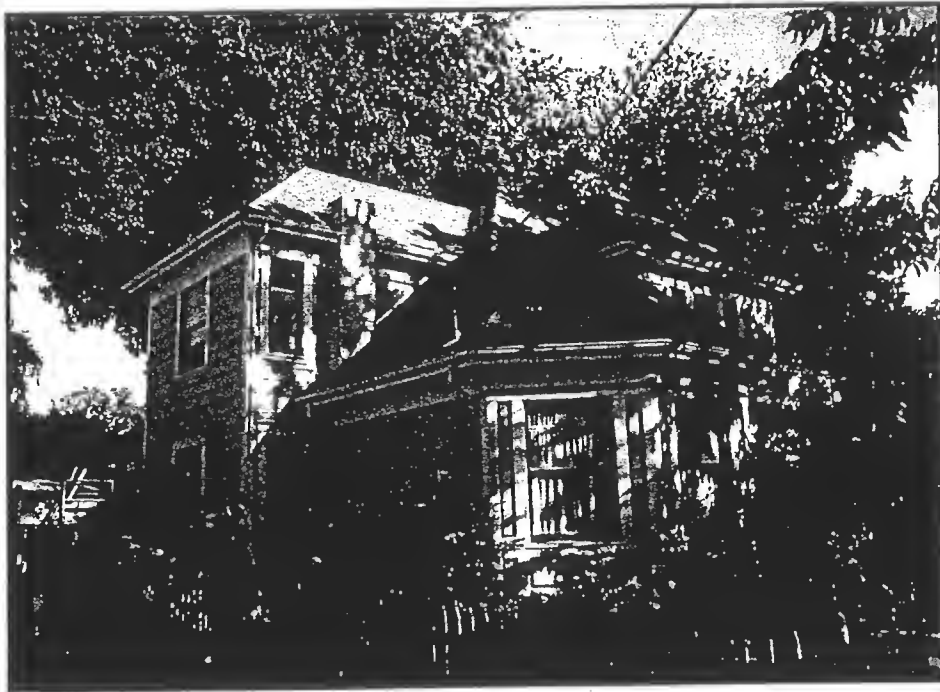
A prominent extended bay window with a pyramidal roof is located on the north side of the front (west) façade. Vertical decorative panels flank the three windows of the bay extension, with decorative recessed panels below them as well. A white-washed brick chimney is located on the front façade, behind the bay extension. On the south side of the front façade is the entry, which is recessed and features a semielliptical arched opening with decorative voussoirs leading to the front door. This door is of simple panel design, with a large light as the upper panel and four smaller panels making up the panels below. The door has small rectangular lights on either side. Above the porch is a cantilevered extension, decorated with clapboard siding, and simple decorative brackets. Above this extension are three one-over-one-light double hung windows, with the center window being wider than the two on either side. 810 ½, the garage and second unit located on the property, has windows that consist of horizontally-oriented two-over-two-light double-hung sash windows.

View of 810 Humboldt, looking southeast.

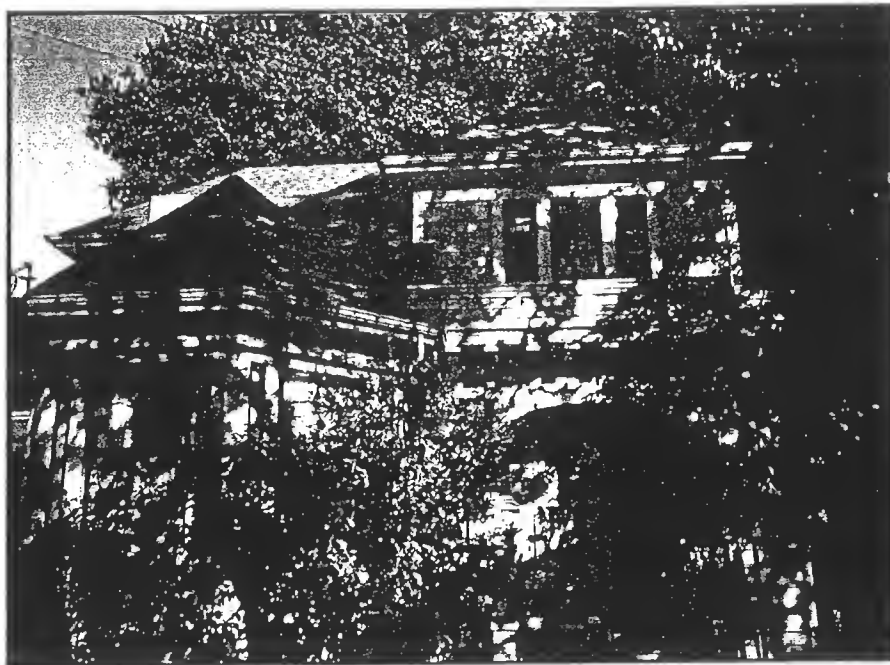
View of 810 Humboldt, looking east.

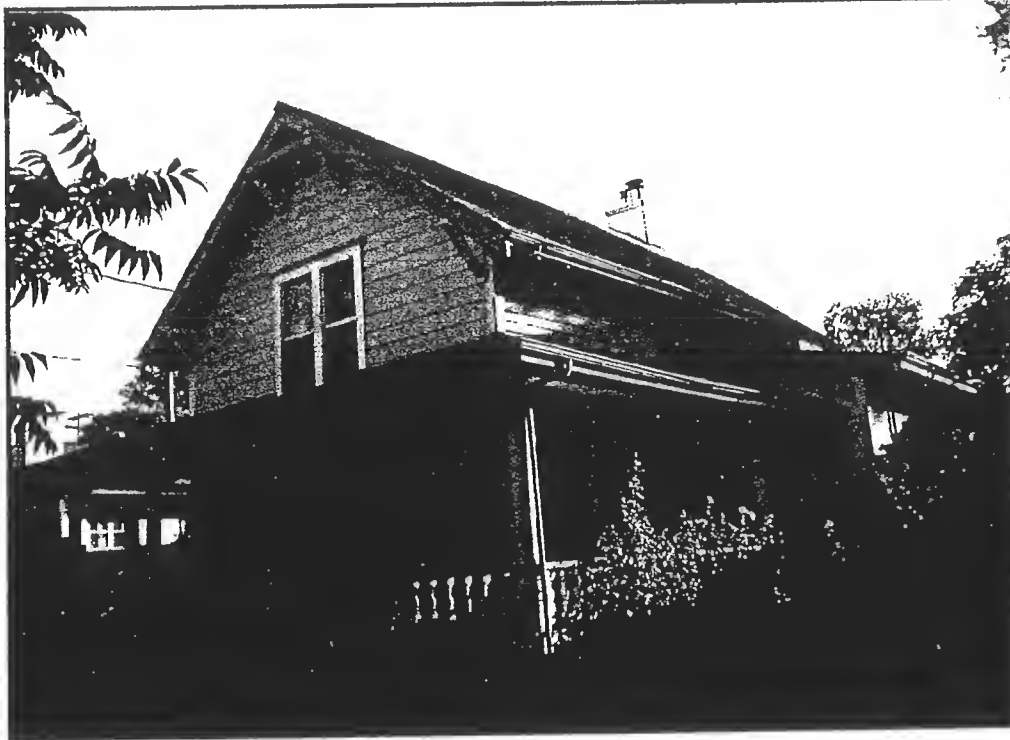
P5b. Description of Photo:  
View of 814 Humboldt, facing  
northeast.

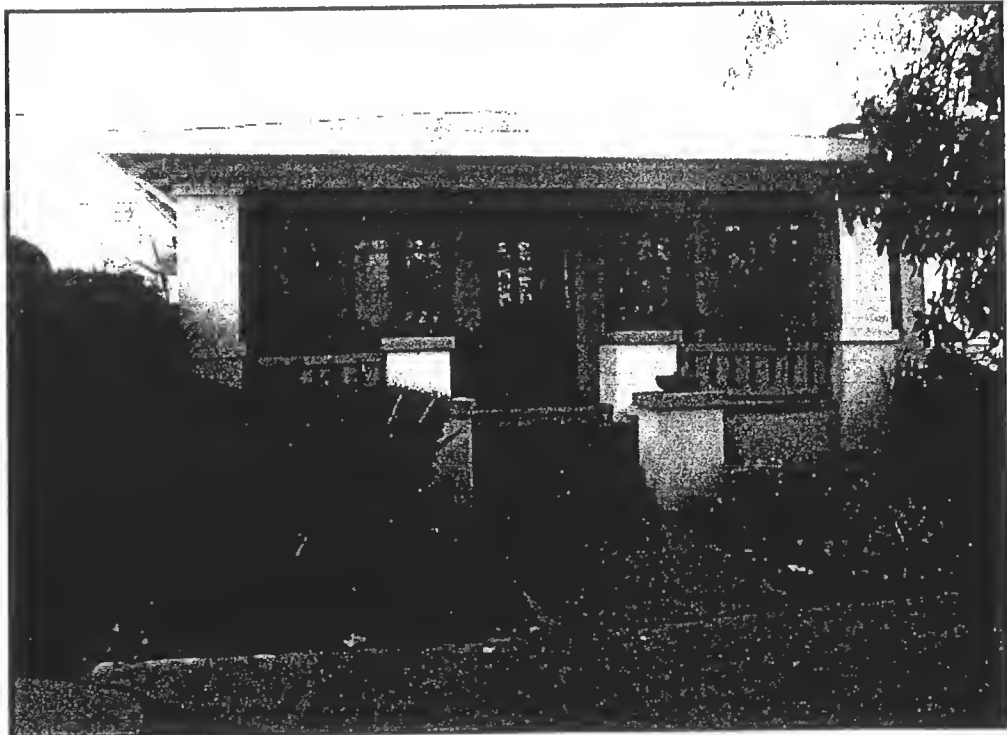
The west façade, fronting Humboldt Street, has a full-width front porch that leads to the two doors. The door to the north (824 Humboldt Street) appears to be the original entry way, due to its symmetrical placement. To the north of this door is a series of four windows comprised of two-over-one-light fixed and casement windows, with the two outside windows being operable. These windows are also present to the south of the southern door (822 Humboldt Street), except it appears the series of four windows were moved south to allow this door to be added. The porch has wide, heavy square columns at the far ends short piers flanking the stair, and a flat board balustrade. The south façade has a small two-over-one-light casement window. West of the chimney that is finished in stucco is another small two-over-one-light casement window, and a pair of four-over-one-light single-hung windows. East of these windows is a pair of one-over-one-light double-hung sash windows. At the far east end of the building is a second level, barely visible from the street, except for the raised hipped roof section. The north façade contains two sets of two-over-one-light vertically-oriented casement windows. East of these is a pair of four-over-one-light single-hung windows and three one-over-one-light double-hung sash windows.

It is unclear when the second unit was created in this building, although the overall character does not seem to have changed dramatically. It appears that they may have extended the south side of the building to accommodate another entry way, as the roof line extends farther on the south end than it does to the north end.

View of 822 / 824 Humboldt, looking east.

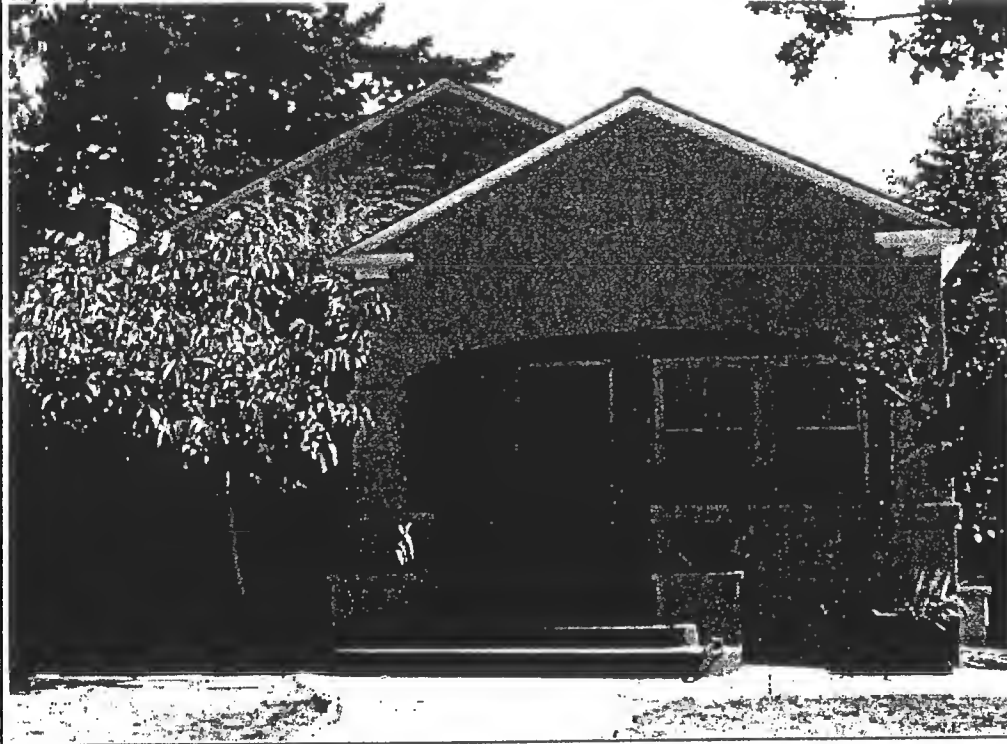
This is a Spanish Revival bungalow. It is a one-story, wood-frame house with stucco exterior with a cross gable shingle roof with the gables facing west and south. The house has a rectangular footprint. The low-pitched roof has cornice returns and molded motif crest is located under each gable. One is in poor condition. The front façade faces west and has a three-bay porch with an elliptical arched opening, two heavy squared porch supports, and four descending steps that widen at the base. The one panel front door has a triangle etched glass insert. To the right of the door are paired windows with a single light on the bottom and lozenge-shaped lights at the top. Both door and windows have simple wood molding all round. The exterior chimney is on the north side of the house, which is partially enclosed by the carport. There are seven windows on the north side of the house. Five are the original one-over-one-light windows and two are newer sliding windows with aluminum sash. A detached garage or small structure partially obscured by foliage can be seen towards the back end of the driveway. On the south side of the house is a large fixed window with an elliptical arched light above the window. On the south side is also the side wing of the cross gable and it too has a three-bay porch with an elliptical arch and two heavy, square porch supports. The door is an aluminum sliding glass door that leads to the dining area. Flanking the sliding door are one-over-one sash windows. The condition of the house appears to be good.

West elevation, viewed from Humboldt

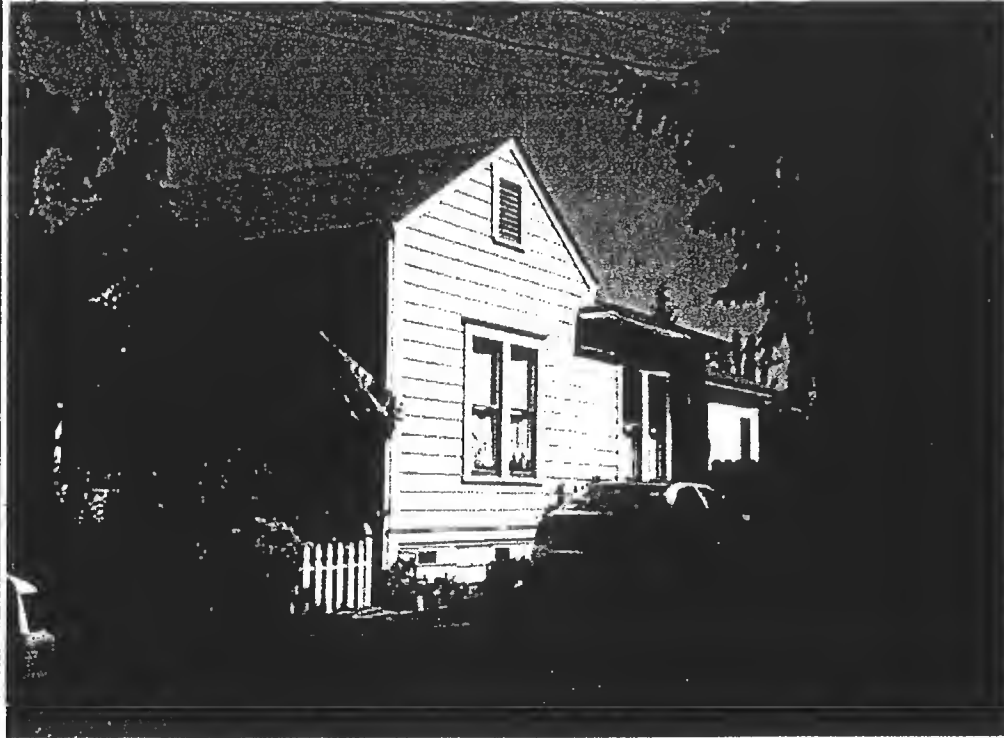
This is a one-story vernacular building constructed in 1896. It is a wood frame house on a square footprint with cross gable roof and a shed roof addition towards back of the house. The roof is composition shingle with ventilators just under the eaves. The front façade faces west and has a one-story porch with two porch supports and double paneled door with two one-over-one-light windows just to the right of the door. At the second level are paired one-over-one-light sash. Four small rectangular vents are located at the concrete foundation. On the north side of the house are three one-over-one-light windows with wood surrounds and crown molding. The south side of the house has two one-over-one-light windows with wood surrounds and crown molding. The addition has a bay window with one-over-one-light windows and wood surrounds. The driveway is on the south side of the property and leads back to a detached garage. The house is in good condition.

P5b. Description of Photo: (View, date, accession #)  
Elevation from the west, view from Humboldt

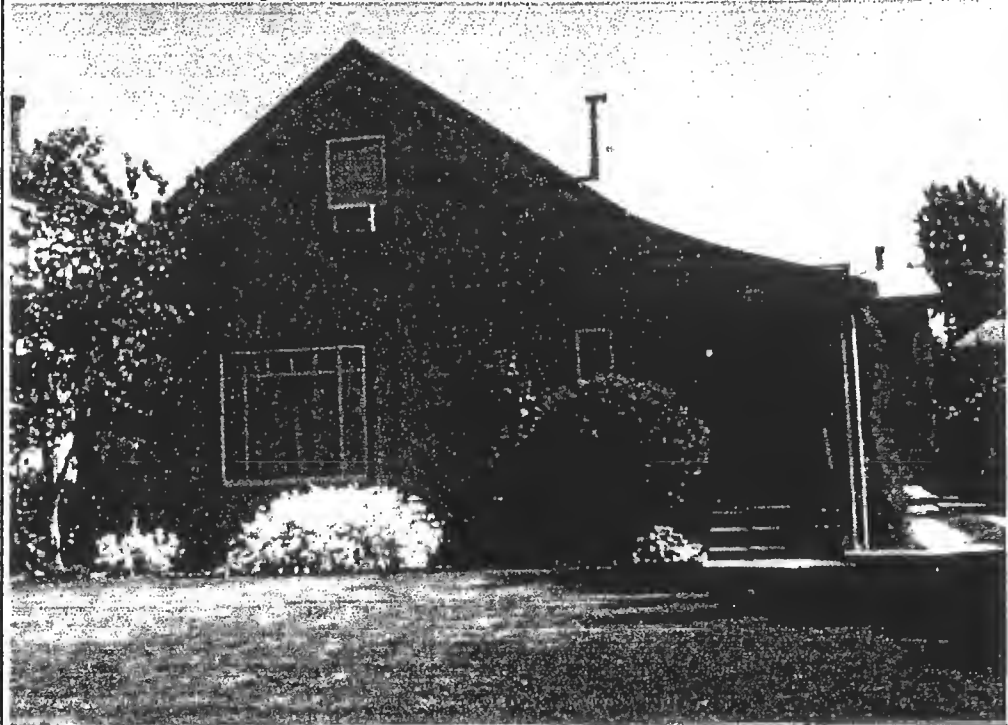
\*P3a. Description: This 1932 vernacular cottage displays modest English Cottage details. It is located on 920 Humboldt with the front façade facing west. It is a one-and-one-half story house with square footprint and a cross gable roof. It features a broken gable extending to the south over the recessed entry south side of the front facade. The roof has a steep pitch and narrow eaves. There is a low foundation that is only visible on the front façade. The roof is composition shingle. The windows are a combination of fixed and sliding sash. The entryway and focal window feature a pedimented enframement. The focal window on the north side of the front façade features a large fixed light with smaller square lights above, and vertical lights to each side. The front door is wood with three narrow, tall lights. The exterior is finished in stucco. There is an exterior stovepipe on the north wall.

P5b. Description of Photo: (View, date, accession #) West facade

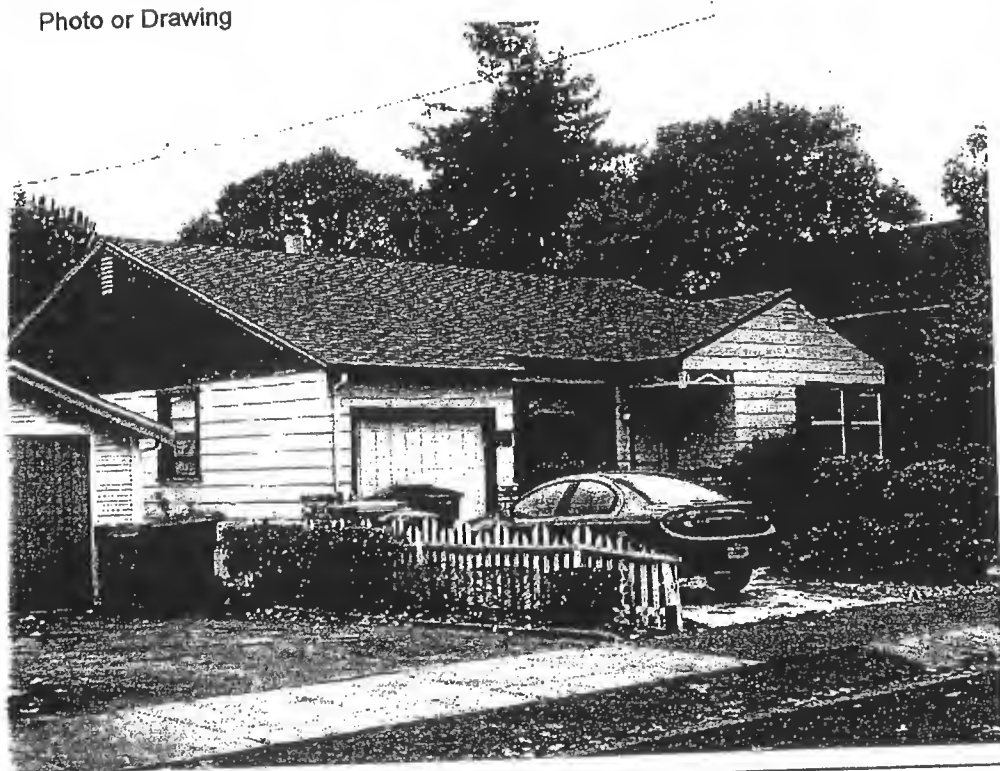
P5b. Description of Photo:  
East-facing elevation, viewed  
from King St. 3 Oct 2004

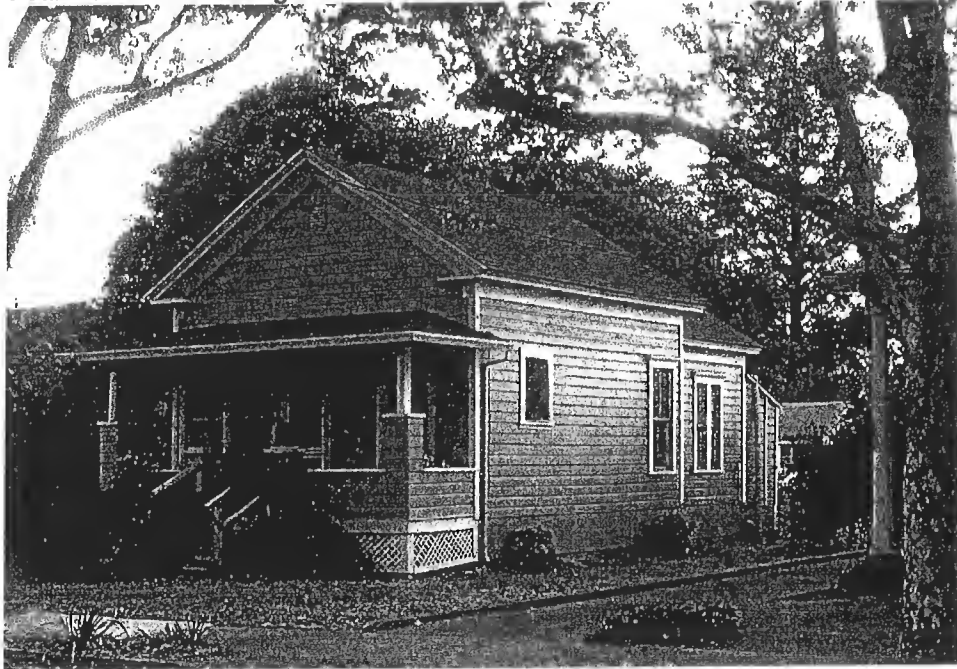
\*P3a. Description: This ca. 1890 one-story house has an L-shaped footprint, and is wood frame construction on a raised concrete foundation. It measures approximately 30 feet across the front and 36 feet down the side, and has a moderately pitched, front-gable roof of composition shingles. The front-facing gable has cornice returns, relatively shallow eaves, and a frieze board. Set back from the front facade and located on the south side of the house, is a side wing with south-facing gable and a vinyl window. The exterior horizontal siding is tongue-and-groove, and there is lattice along the front beneath the porch on both sides of the entry stairs.

East-facing elevation, viewed from  
King St. 3 Oct 2004

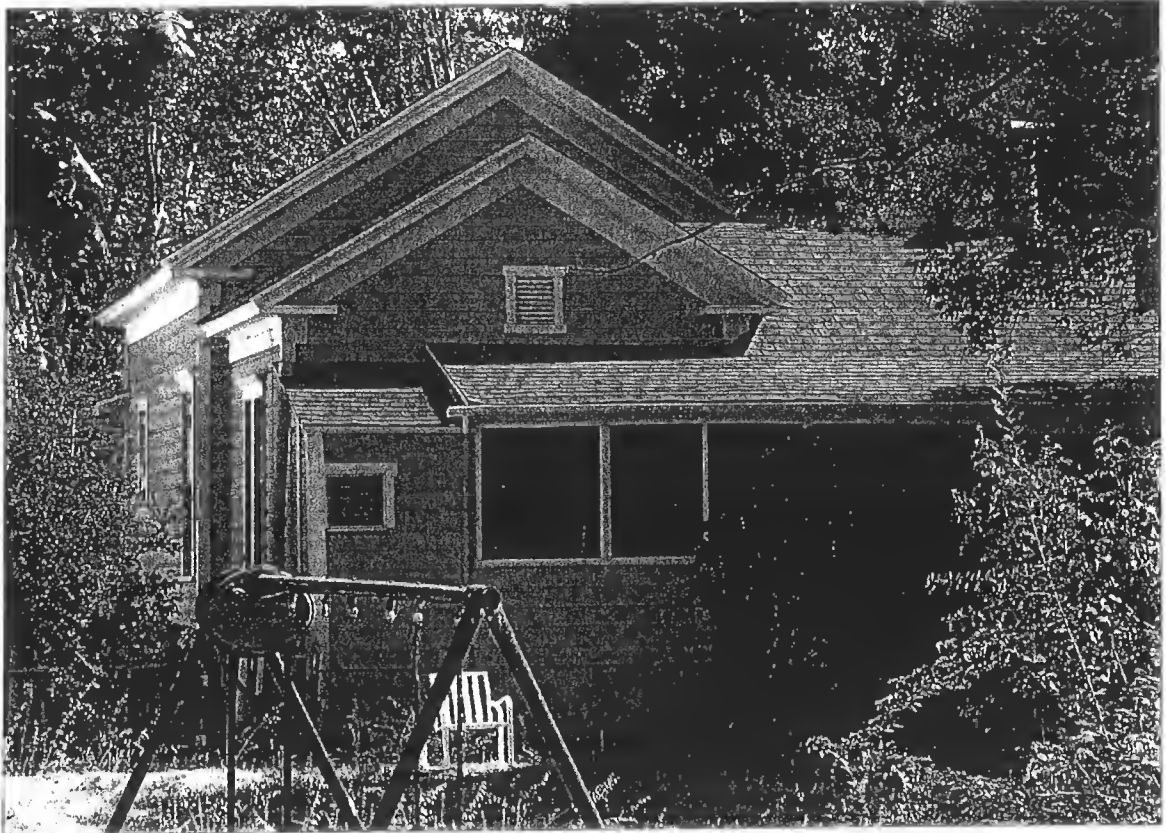
West-facing elevation (rear view), viewed from alley between Benton and Howard streets.

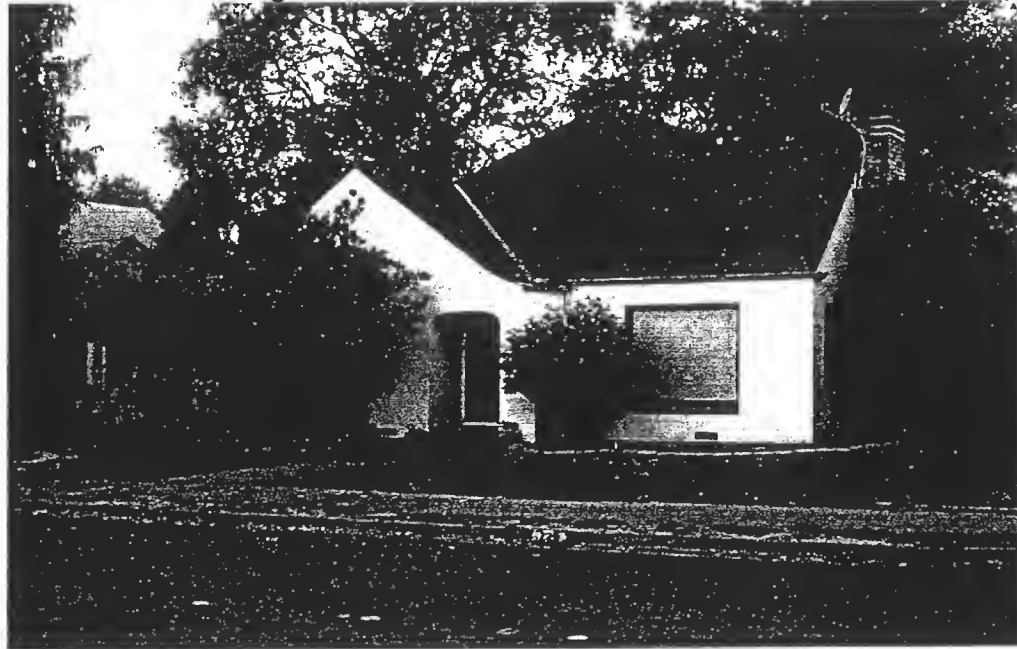
This house is situated on the southwest corner lot at the intersection of King and Howard streets, with the entrance oriented east toward King Street. It is a roughly L-shaped structure on a concrete foundation with a stucco finish. Constructed in 1938, it measures about 55 feet across the front by about 40 feet in depth. The facade has a front-facing gable on the south side and a large fixed window on the north side. There is an extension to the left of the front facade, set back approximately 20 feet. It has a gabled dormer containing one vinyl sliding window (2 two-over-three lights) and a gabled entrance door and double-hung, four-over-four window. Both gable facades have horizontal wood siding, which contrasts the stucco finish, suggesting remodeling has occurred (see continuation sheet).

East-facing elevation, viewed from King St. 3 Oct 2004

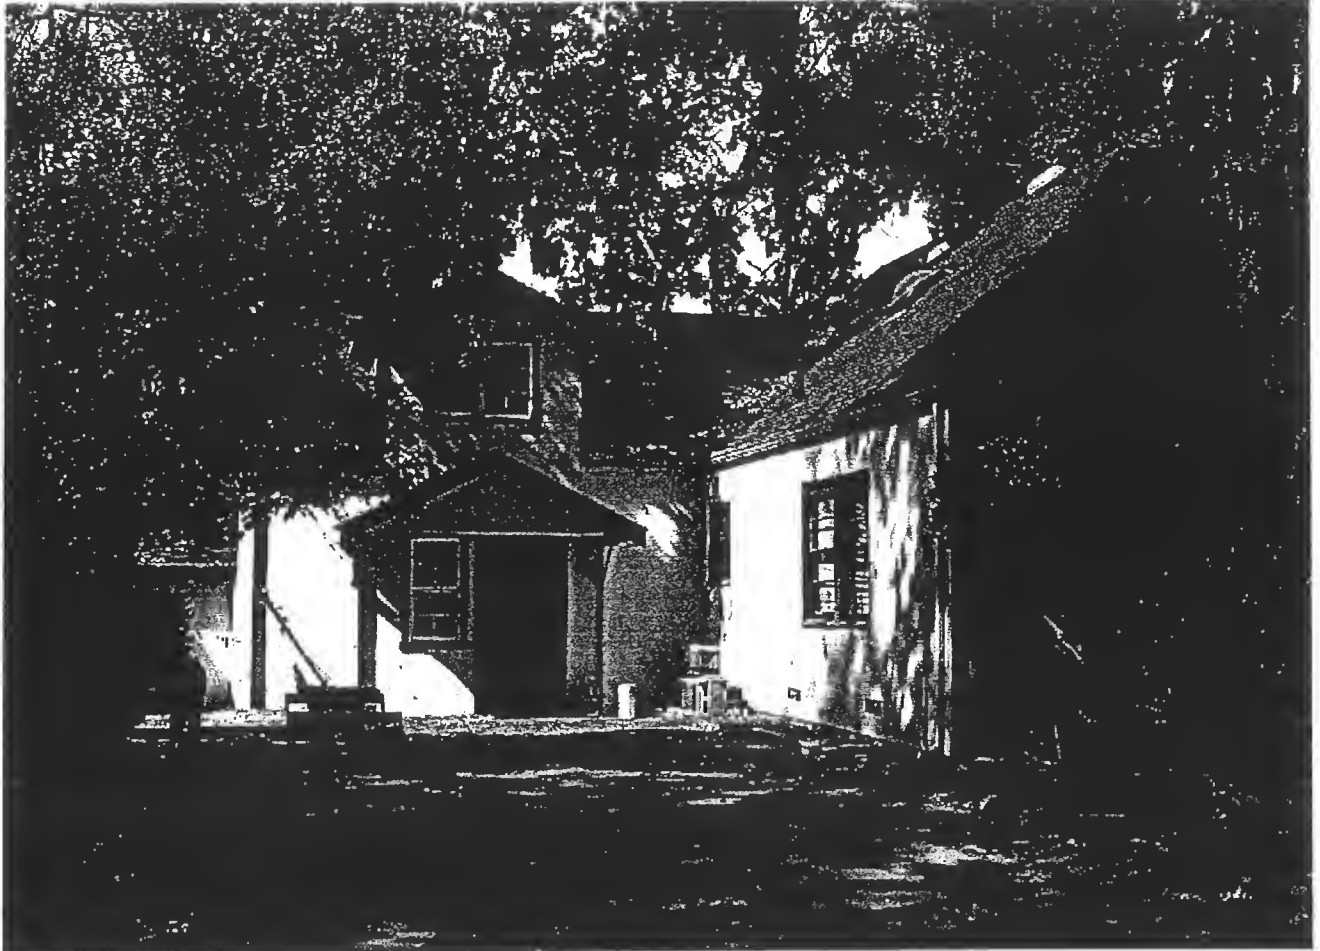
\*Resource Name or #: 729 King St.

The rear addition on the left of the front facade. East-facing elevation, viewed from King St. sidewalk.

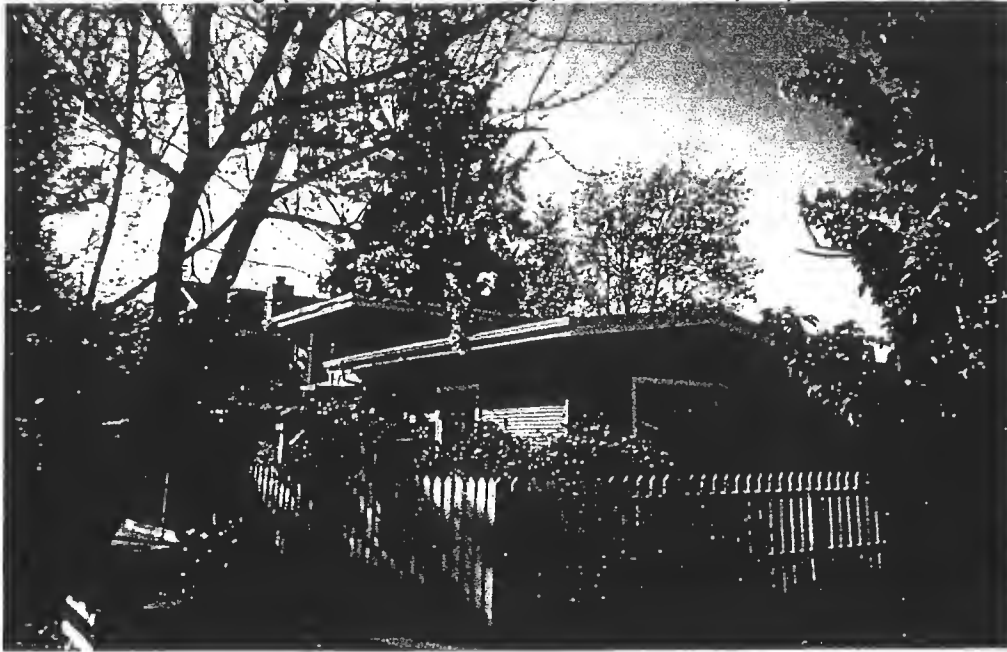
P5a. Photo or Drawing (Photo required for buildings, structures, and objects.)

\*P3a. Description: (Describe resource and its major elements. Include design, materials, condition, alterations, size, setting, and boundaries)  
This is a Craftsman bungalow that has been modified. It is one story at the front of the house, and two stories to the rear. The building, which has a nearly square footprint, faces east onto King Street. This façade has a shallow-pitched gable roof on the main body of the structure, and a shallow-pitched gable roof over what had been the front porch on the south side of the east façade. This has been enclosed and features a large fixed picture window. The entry, which faces north, is covered with an open trellis. The main part of the east façade, on the north end, features a two-light fixed window with vertically-oriented lights. A two-story addition is located on the west façade; this has a nearly flat roof, and features double-hung, vinyl windows with wood surrounds. A second trellis is located in the south yard; this is within an area with a tall fence that abuts the back of sidewalk.

P5b. Description of Photo: (View, date, accession #) View from King Street looking west, April 2005
